# Vermont's Slope Stability Challenges Highlight the Need for Resilient Solutions

BY: SHAWN KELLEY, PHD, PE ON SEPTEMBER 10, 2024

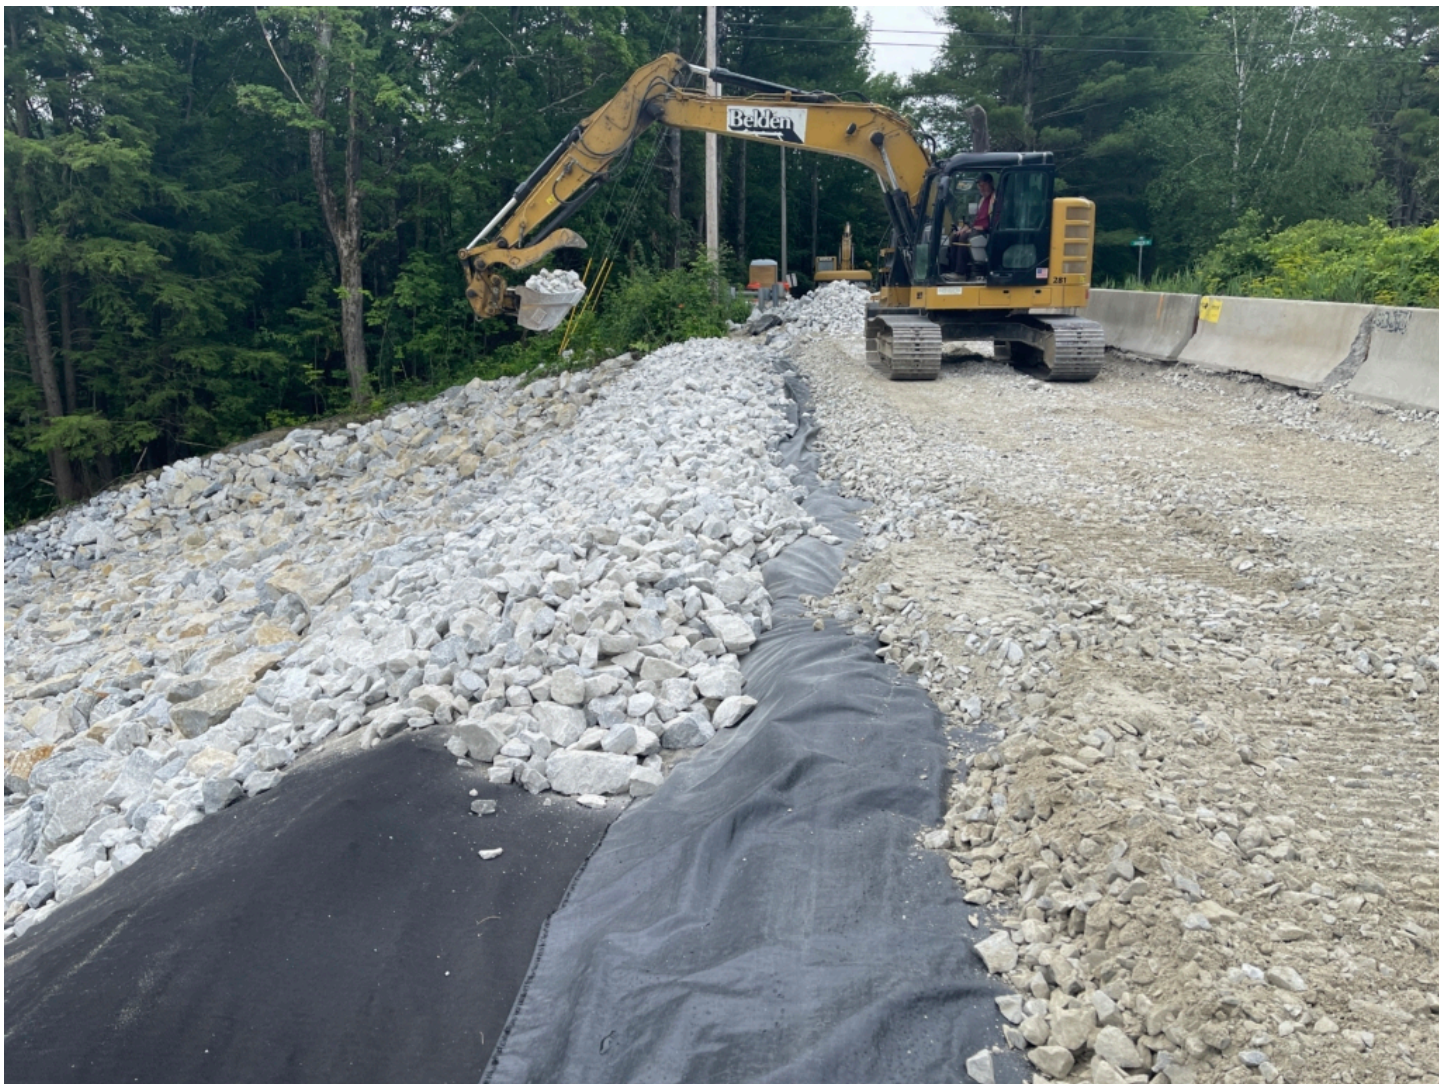
An example of a Level 3 resilient design is the [reconstruction of Dewey Avenue in West Rutland, VT](#). Source: Sanborn, Head & Associates, Inc.

- **Level 3 – High-Risk Slopes**
  - **Resource Investment:** Very High
  - **Resiliency:** High
  - **Risk of Future Instability:** Low

Level 3 provides a more complex and resilient design. It is typically considered a “betterment” and provides a slope repair with the highest level of resiliency against future storms and damage, versus “in-kind” repairs which replace the slope with its original geometry.

For example, stone riprap with a stone buttress is constructed with additional design features that may include stormwater management (i.e., underdrains or additional culverts to divert surface water from the slope), reduction of driving forces that cause instability (i.e., the use of lightweight materials such as Geofoam, [Ultra-Lightweight Foamed Glass Aggregate](#) (UL-FGA), lightweight stone aggregate), and additional resisting forces (i.e., soil nails, toe walls, etc.).

This solution addresses future groundwater rises or big storm events by anticipating how water will impact the system and building defenses against future flooding. Because of this “betterment” designation, Level 3 solutions typically require substantial federal or state transportation funds.

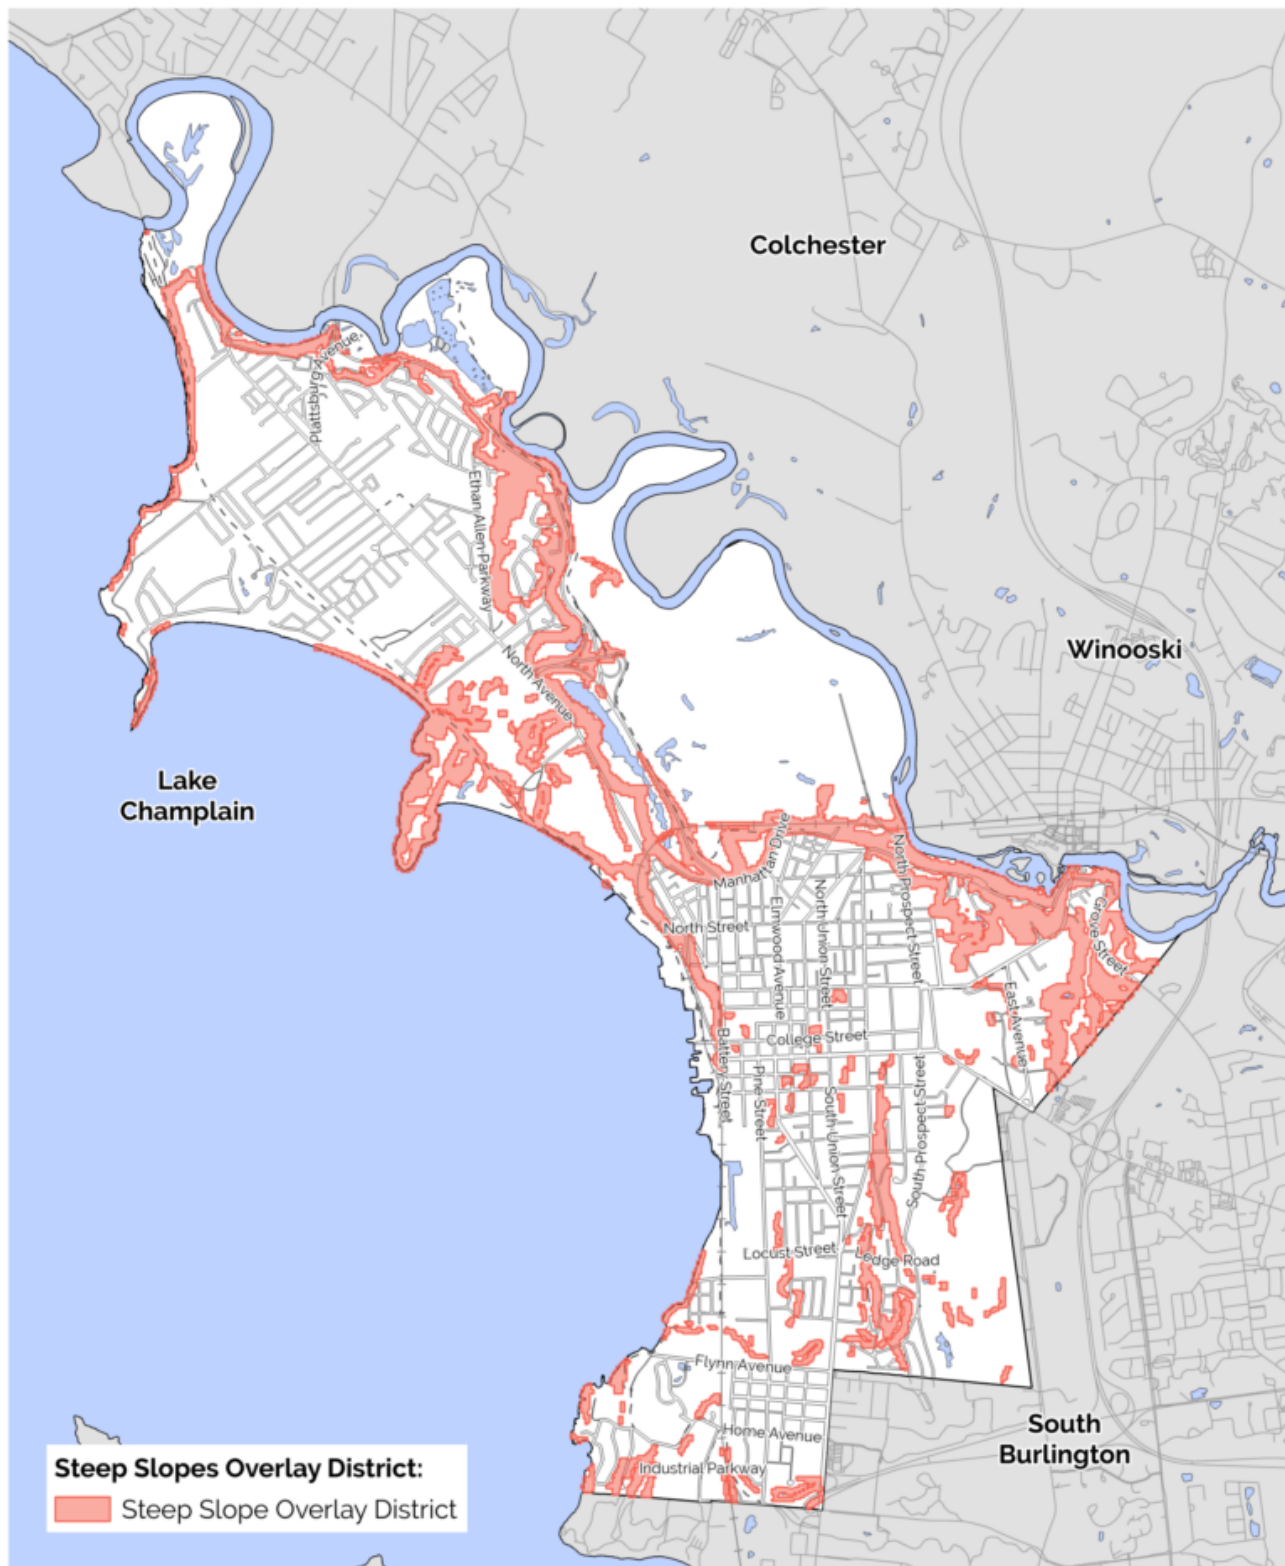
### Steep Slopes Overlay District Map

Burlington Comprehensive Development Ordinance, Map 5.2.4-1  
Overlay district effective 10-12-2022 (from ZA-22-03)

Steep slopes overlay. Source: [City of Burlington, VT](#)

In Burlington, Vermont, the “[Comprehensive Development Ordinance](#)” addresses flood resilience and the fragility of steep slopes by designating specific, more flood-prone areas as “slope-weary.” The ordinance requires developers/homeowners to conduct a slope stability analysis before any new construction occurs. It also includes stricter requirements for new construction and substantial improvements in areas at risk of flooding, updated definitions, and clearer guidelines for floodplain management.
