Vermont's Slope Stability Challenges Highlight the Need for Resilient Solutions

BY: SHAWN KELLEY, PHD, PE ON SEPTEMBER 10, 2024

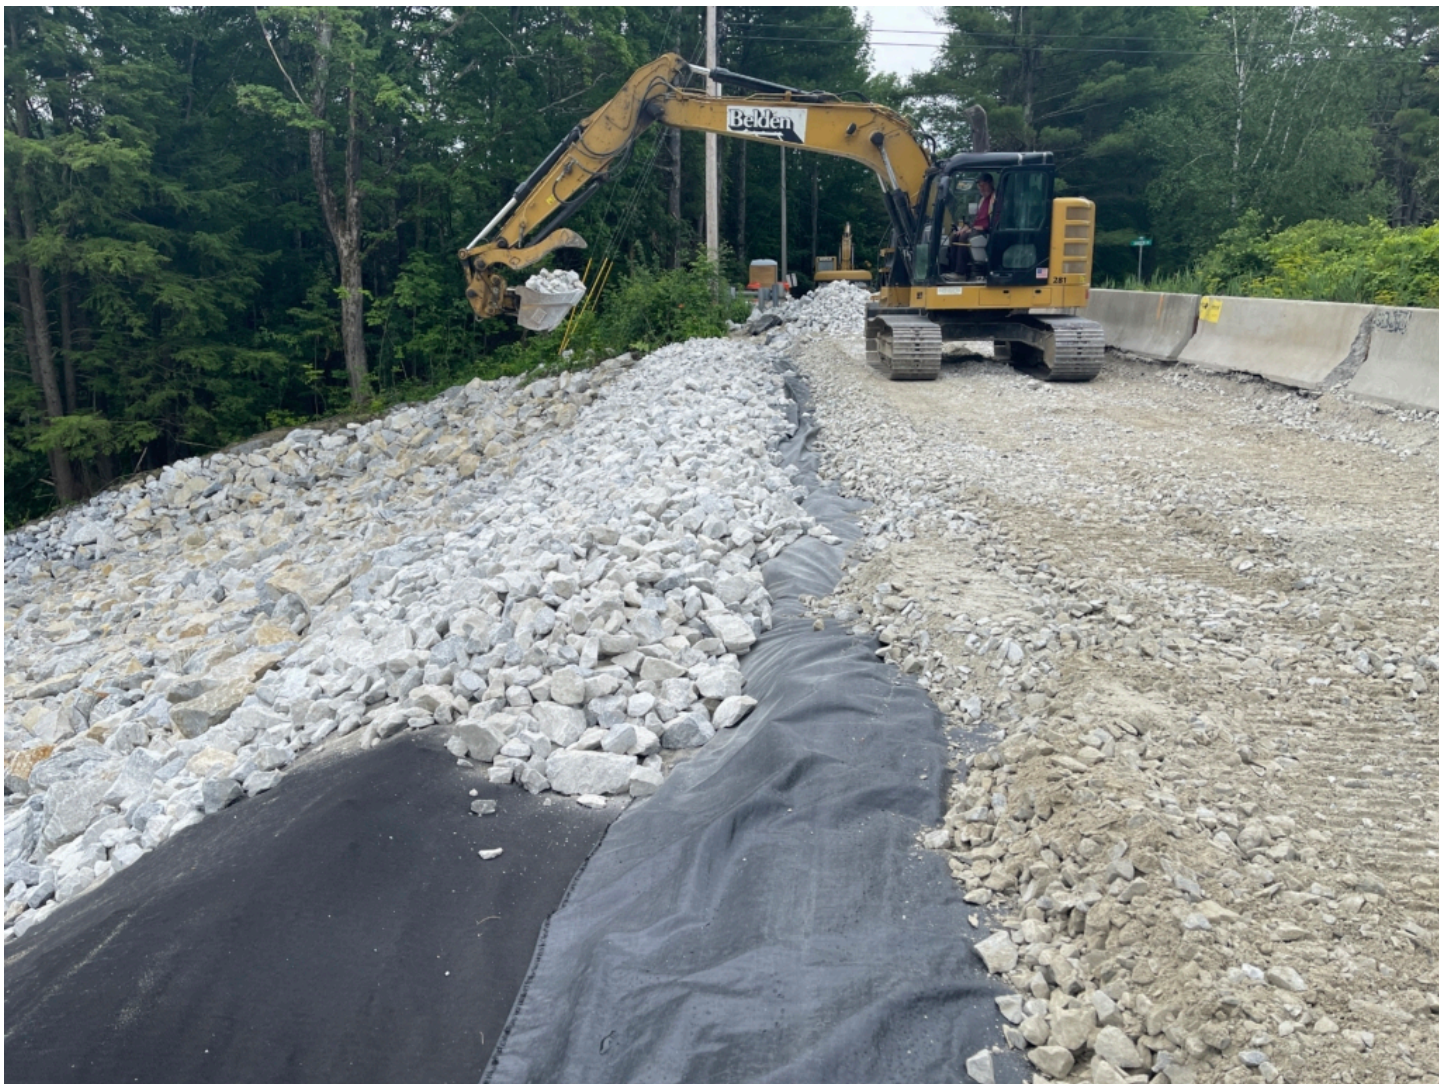
An example of a Level 3 resilient design is the [reconstruction of Dewey Avenue in West Rutland, VT](#). Source: Sanborn, Head & Associates, Inc.

Level 3 provides a more complex and resilient design. It is typically considered a “betterment” and provides a slope repair with the highest level of resiliency against future storms and damage, versus “in-kind” repairs which replace the slope with its original geometry.

For example, stone riprap with a stone buttress is constructed with additional design features that may include stormwater management (i.e., underdrains or additional culverts to divert surface water from the slope), reduction of driving forces that cause instability (i.e., the use of lightweight materials such as Geofoam, [Ultra-Lightweight Foamed Glass Aggregate](#) (UL-FGA), lightweight stone aggregate), and additional resisting forces (i.e., soil nails, toe walls, etc.).

This solution addresses future groundwater rises or big storm events by anticipating how water will impact the system and building defenses against future flooding. Because of this “betterment” designation, Level 3 solutions typically require substantial federal or state transportation funds.

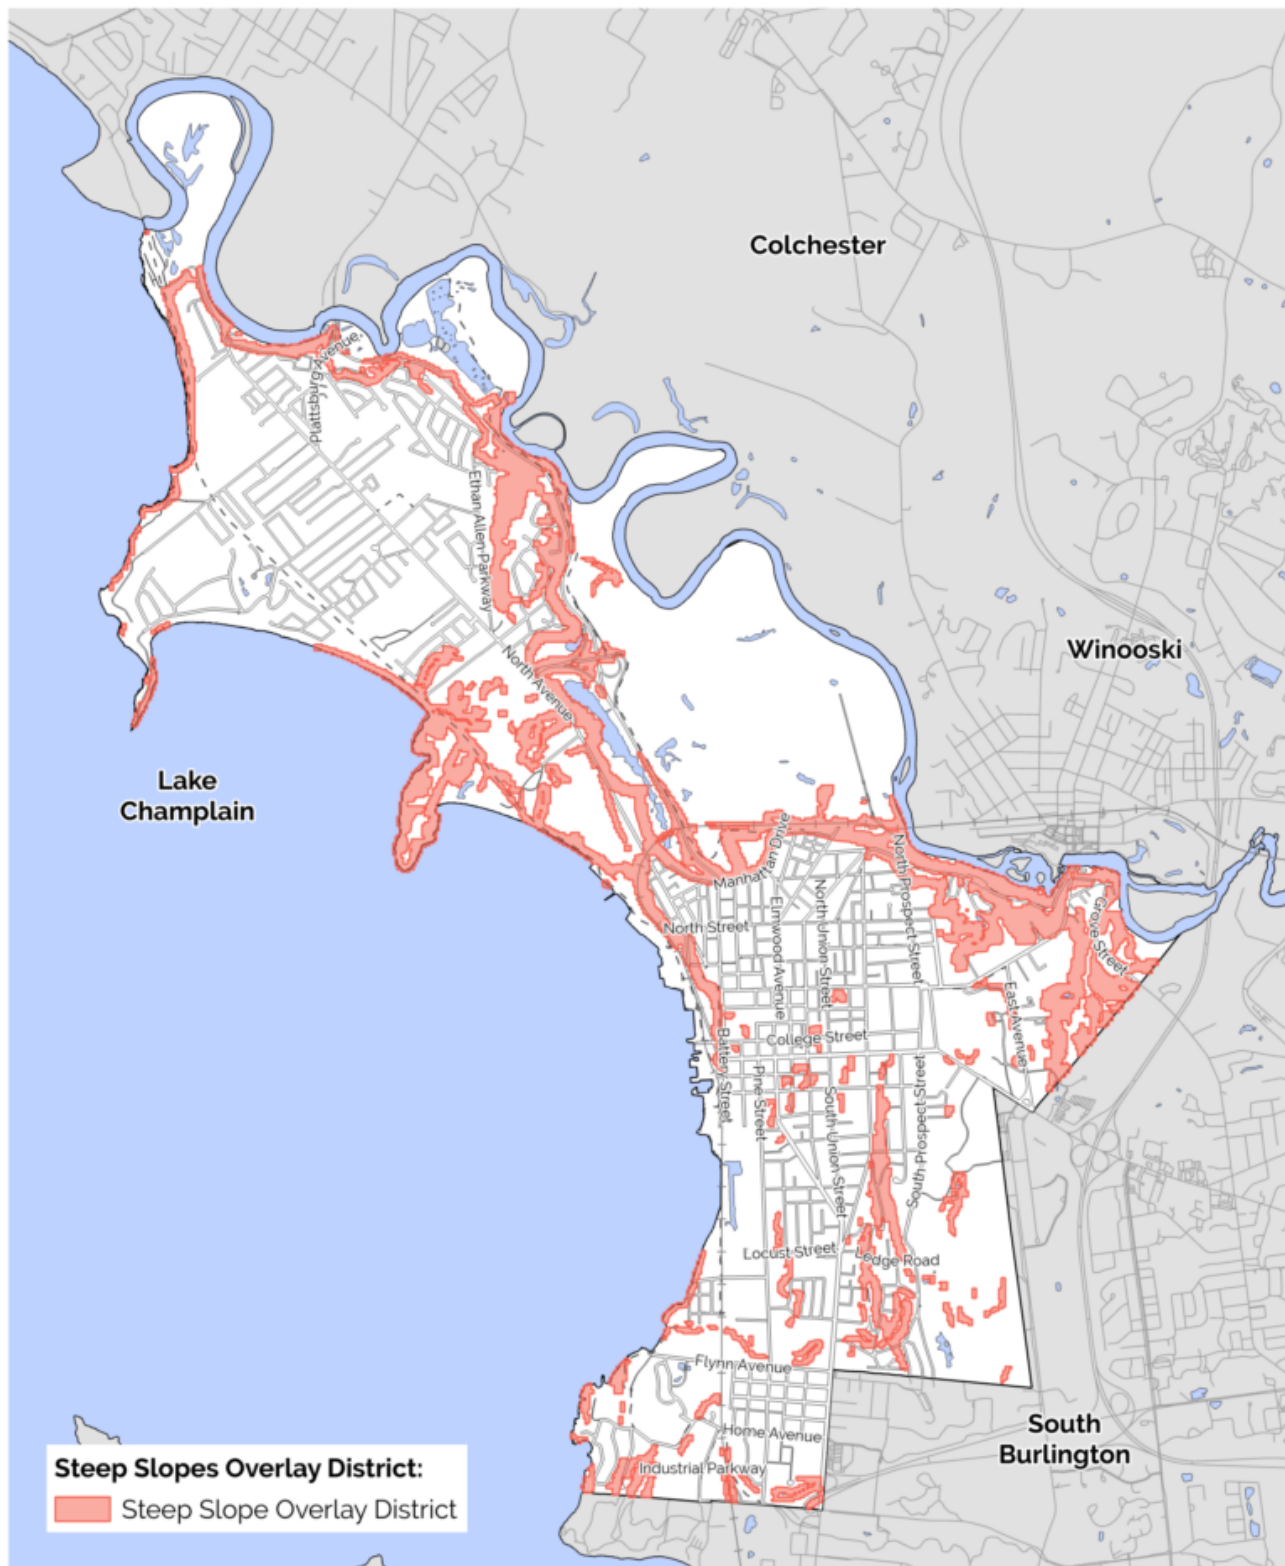
Steep Slopes Overlay District Map

Burlington Comprehensive Development Ordinance, Map 5.2.4-1
Overlay district effective 10-12-2022 (from ZA-22-03)

Steep slopes overlay. Source: [City of Burlington, VT](#)

In Burlington, Vermont, the “[Comprehensive Development Ordinance](#)” addresses flood resilience and the fragility of steep slopes by designating specific, more flood-prone areas as “slope-weary.” The ordinance requires developers/homeowners to conduct a slope stability analysis before any new construction occurs. It also includes stricter requirements for new construction and substantial improvements in areas at risk of flooding, updated definitions, and clearer guidelines for floodplain management.
